Rocklin Academy-Citrus Heights

Arborist Report

July 2021 | TII-01

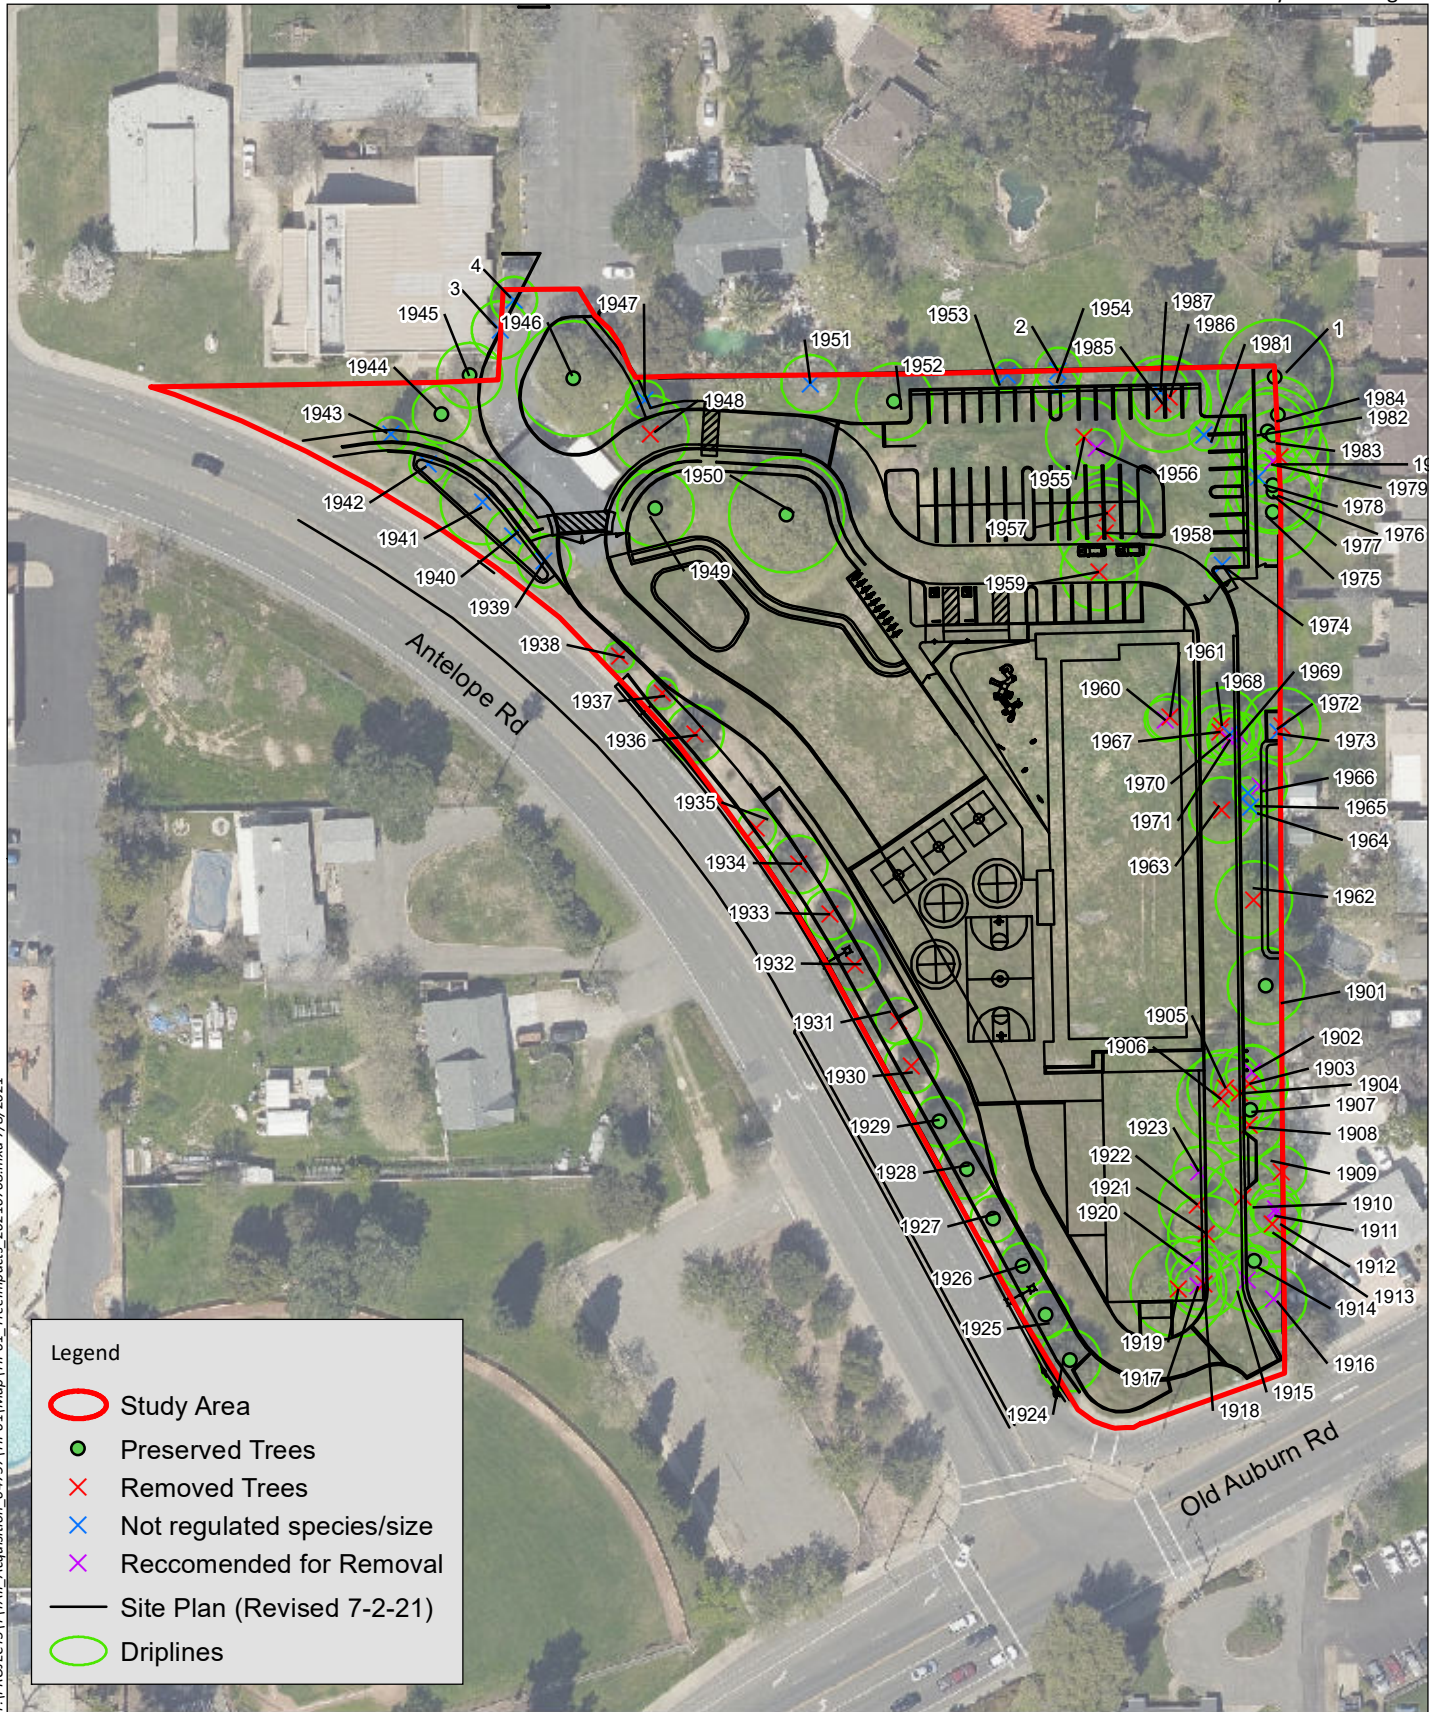
All trees rooted in or overhanging the project site were mapped using a Trimble Geo XT GPS receiver with sub-meter accuracy. Trees were identified in the field with permanent numbered metal tags. A tree map is provided in Figure 2, *Approximate Tree Locations and Project Impacts*.

Grading, ground disturbance impacts, and permanent improvements will occur within the dripline of tree #1950. The proposed improvements would impact approximately 17.8 % of this tree's dripline area. Impacts are not expected to be substantial enough to permanently affect the tree, however, the General
